The Forensic Investigation of Domestic Property Fraud

CII Local Institutes Conference 2019

18 September 2019

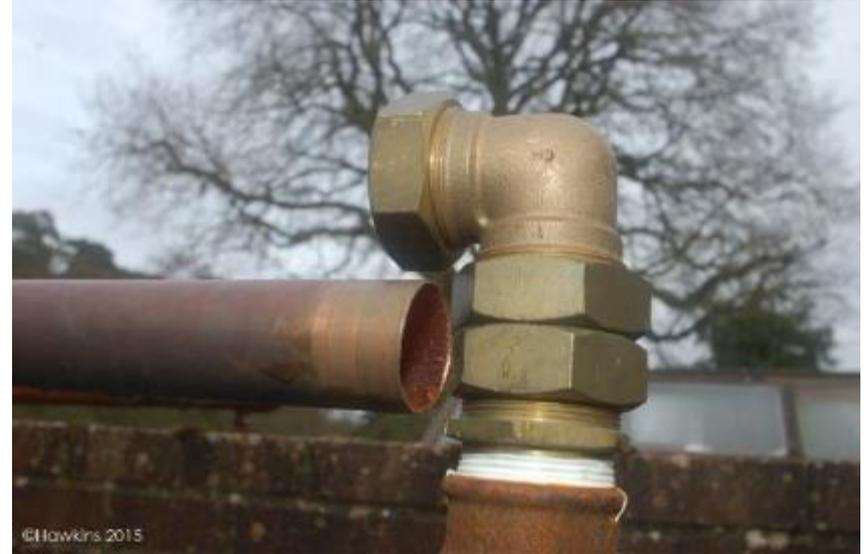
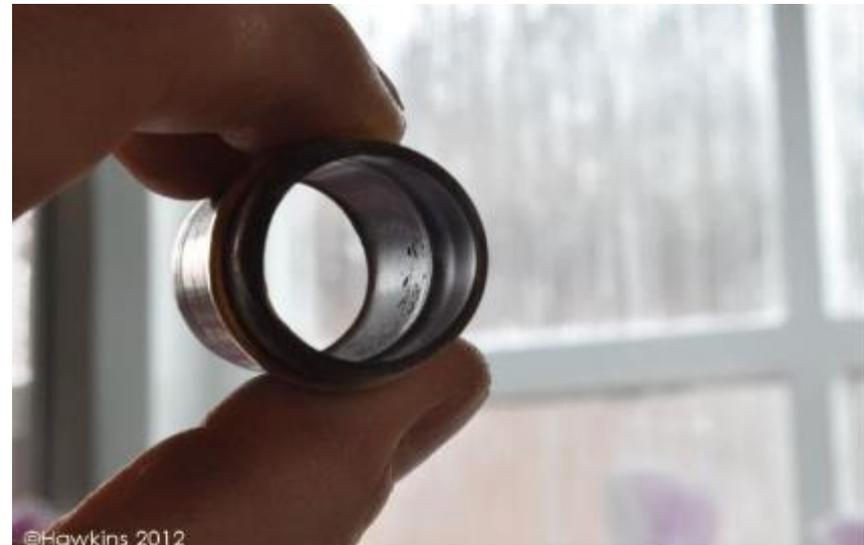
- Witness marks showing evidence of installation
- Joints that have been repaired will often exhibit multiple sets of marks
- The pipe end is just as important as the fitting
- Extremely large forces are required to pull apart a well made joint

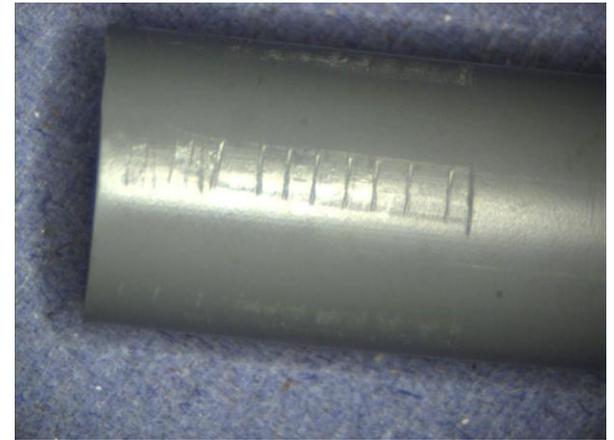
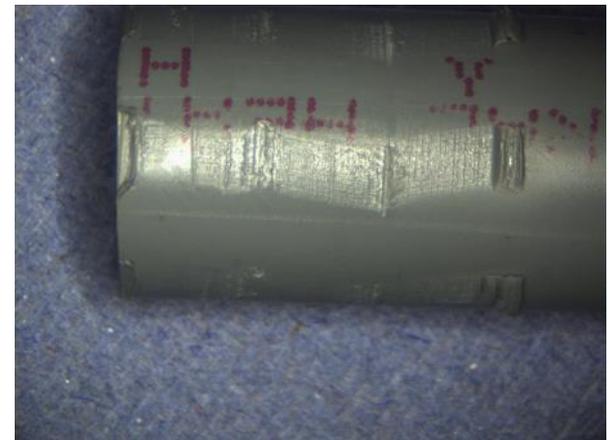
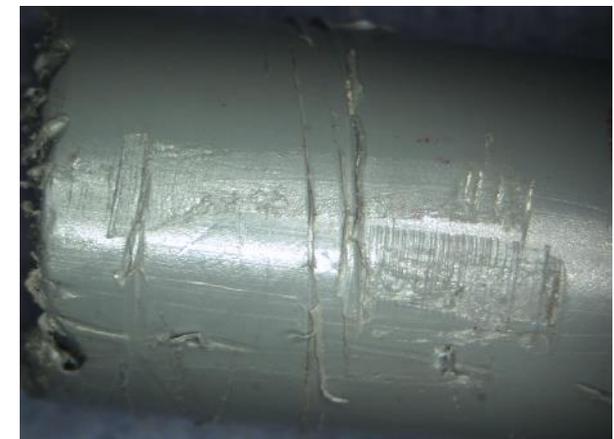
- The pipe is more useful than the fitting
- Plastic pipe is perfect for preserving witness marks
- Replicate damage in repeatable tests
- If the pipe is reused the original separation marks will still be present
- If there are no marks present then the pipe was never inside the joint (this could be poor workmanship as well)

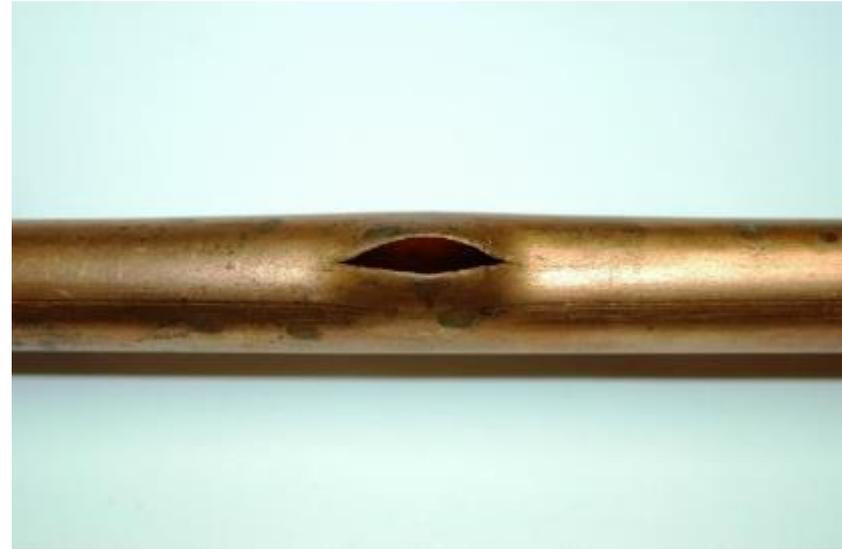
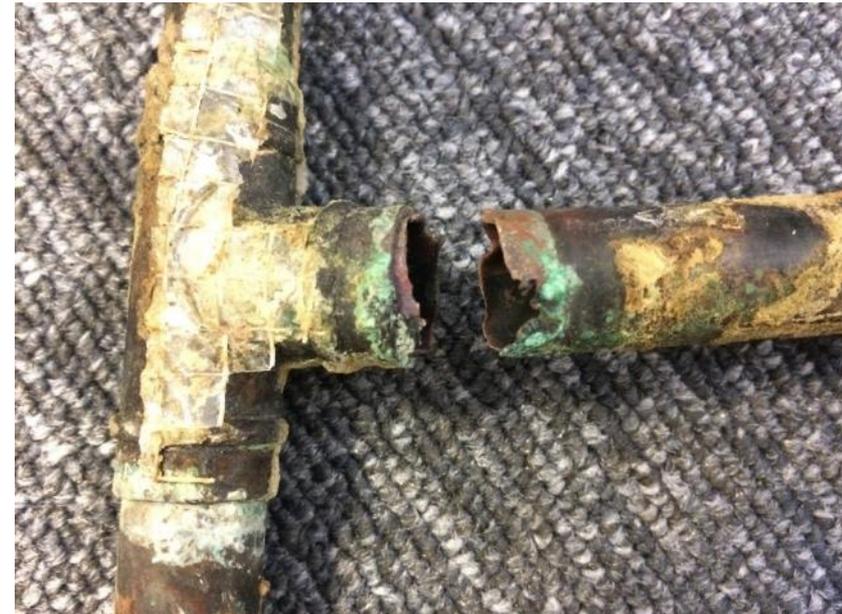
- When a material fractures, patterns in the surface are created.
- If the surfaces are preserved these clues can help establish what has occurred
- The fracture patterns tell us where a crack started and how quickly it grew.
- The patterns can also indicate when unusual forces have been applied and in what direction.

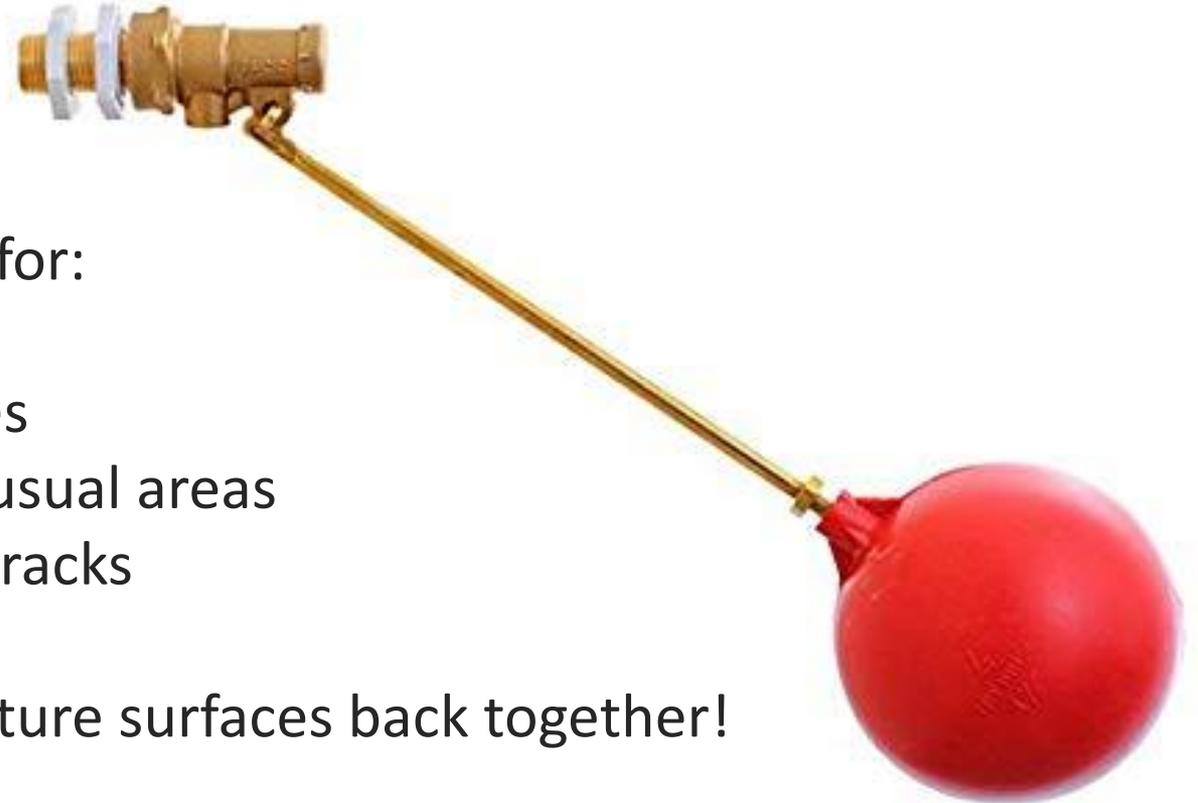
- Be on the look out for:
 - Tool marks
 - Smooth surfaces
 - Fractures in unusual areas
 - Lots of jagged cracks
- Do not put the fracture surfaces back together!

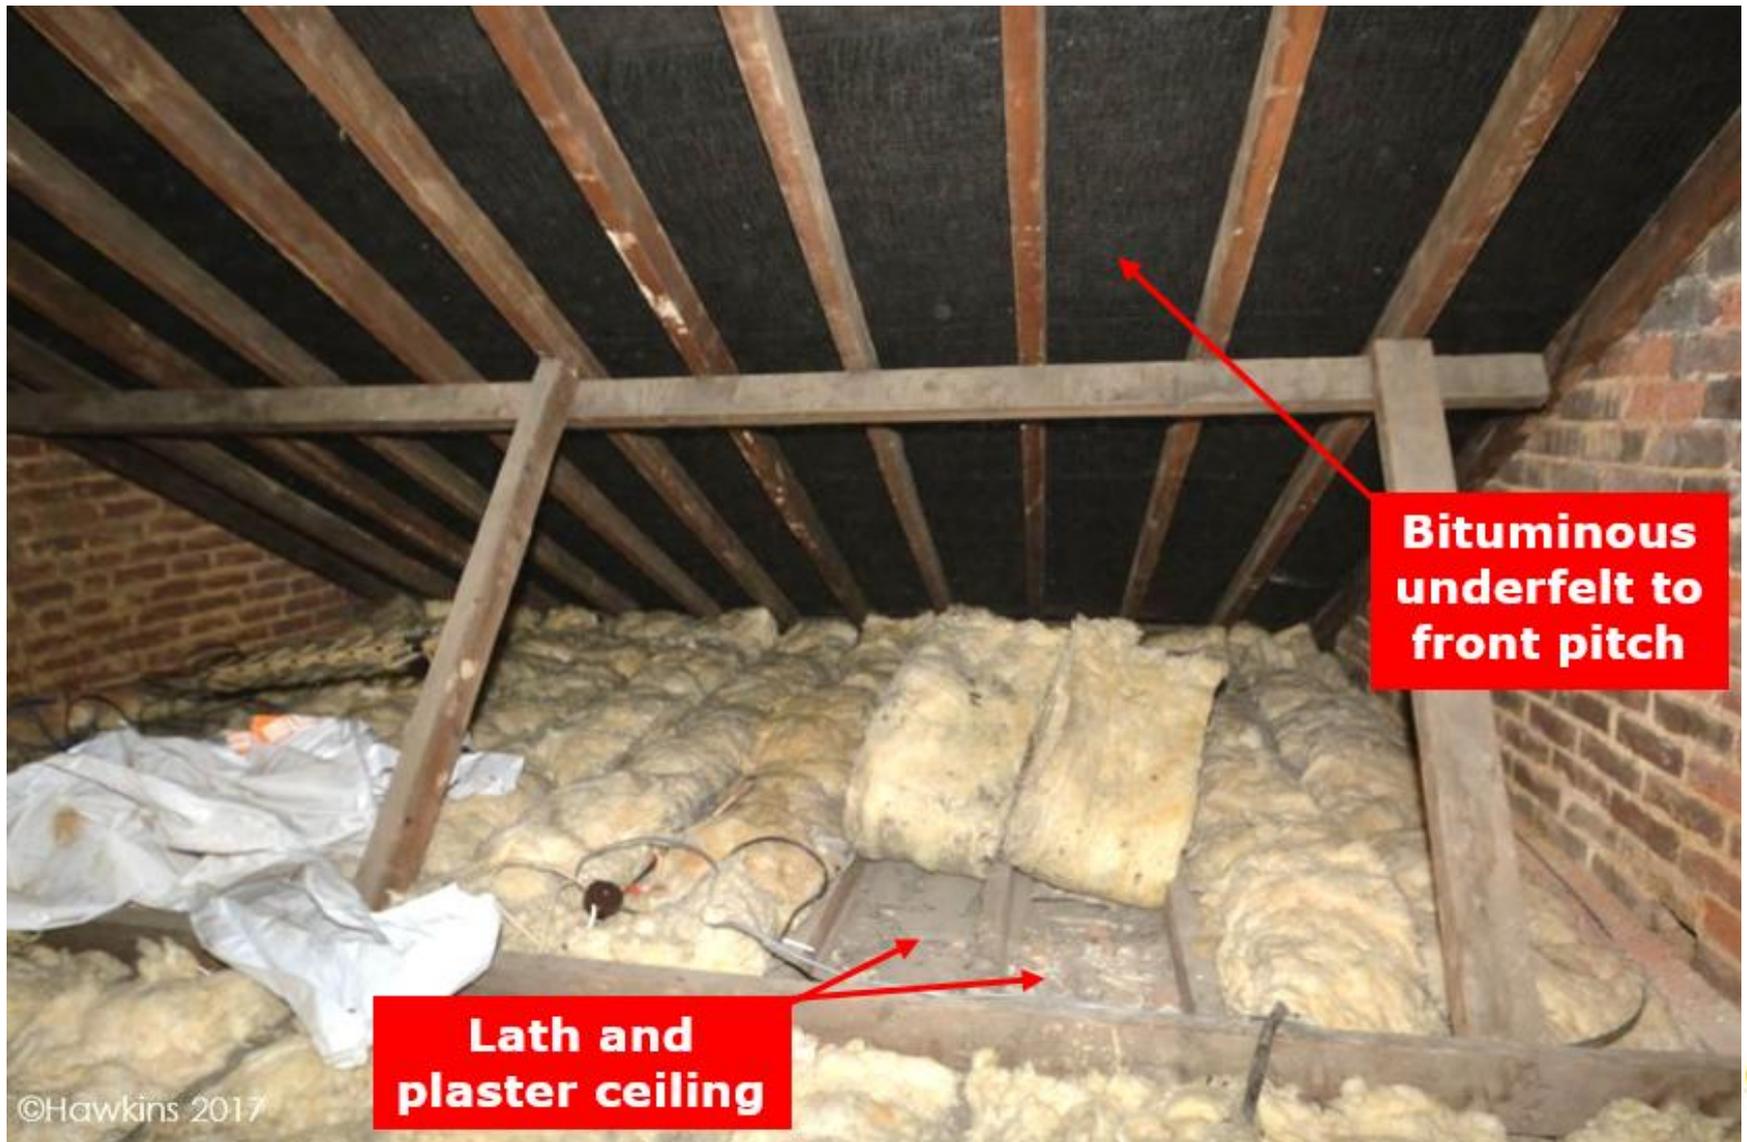
Main terrace loft, looking towards the front

**Lath and
plaster ceiling**

**Bituminous
underfelt to
front pitch**

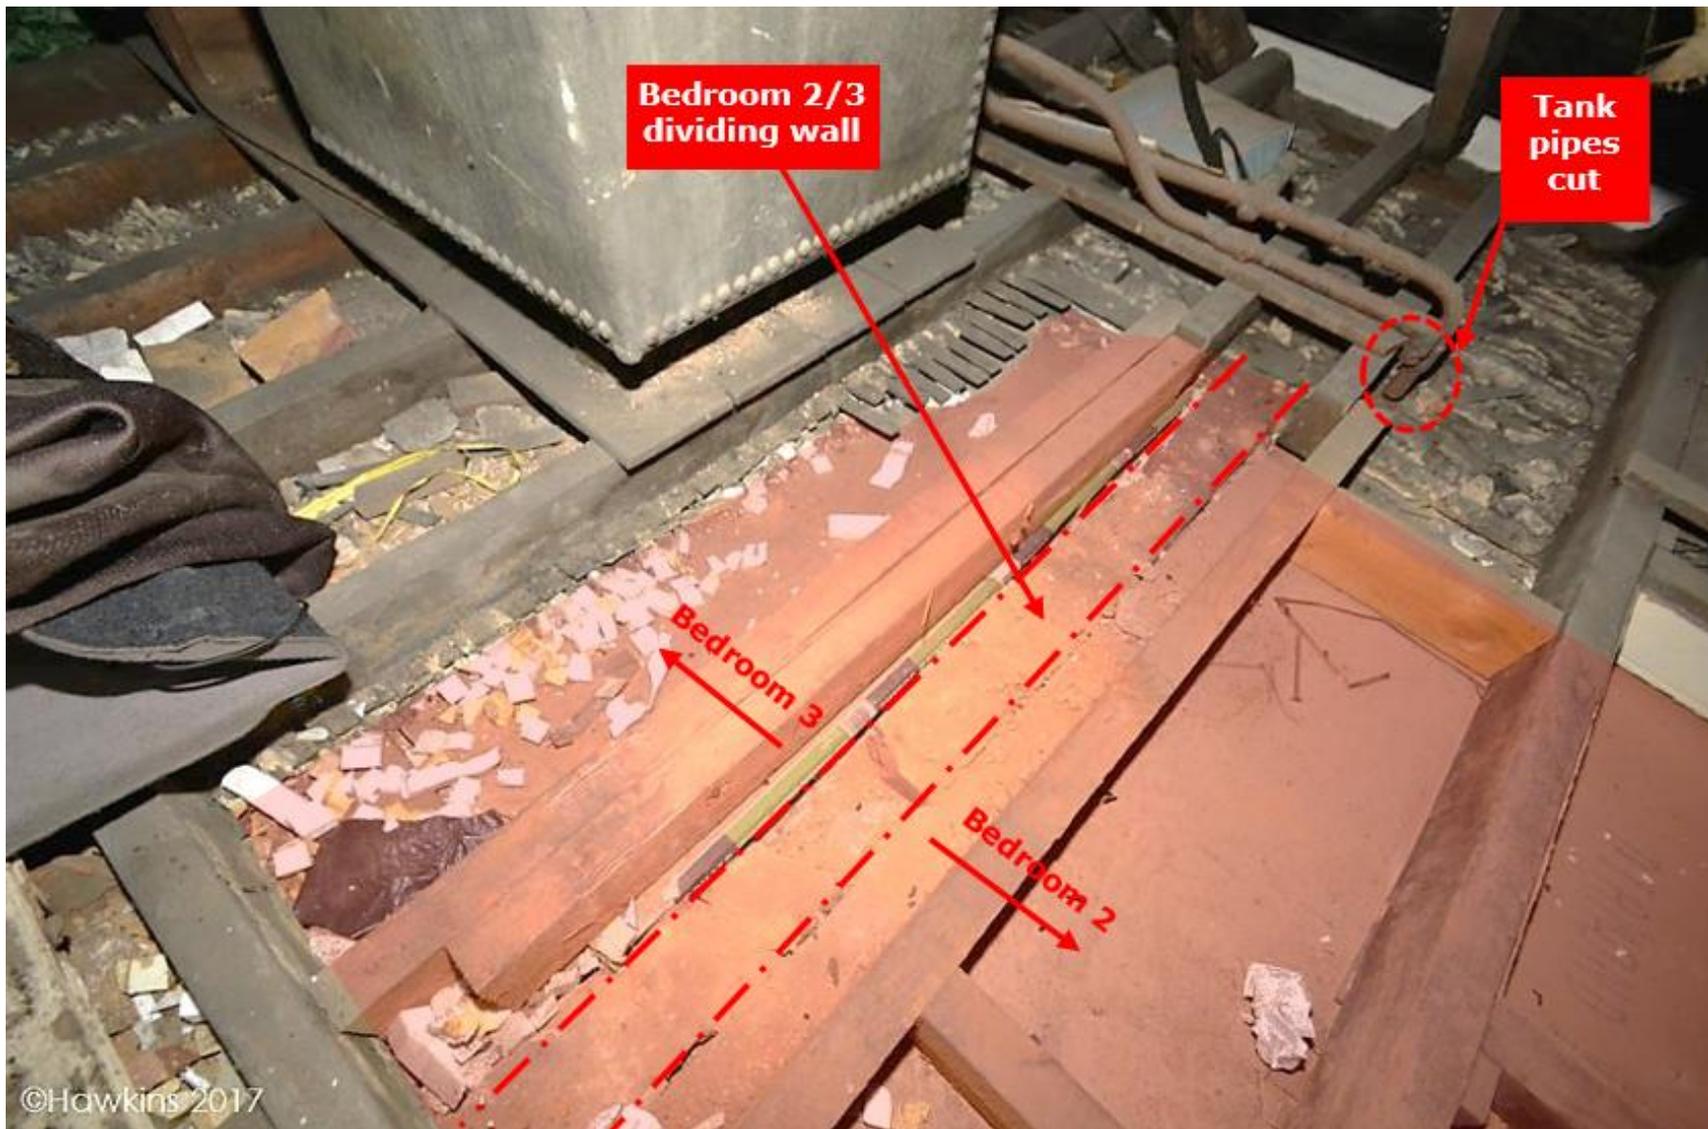
Lath and plaster ceiling to rear of tanks replaced

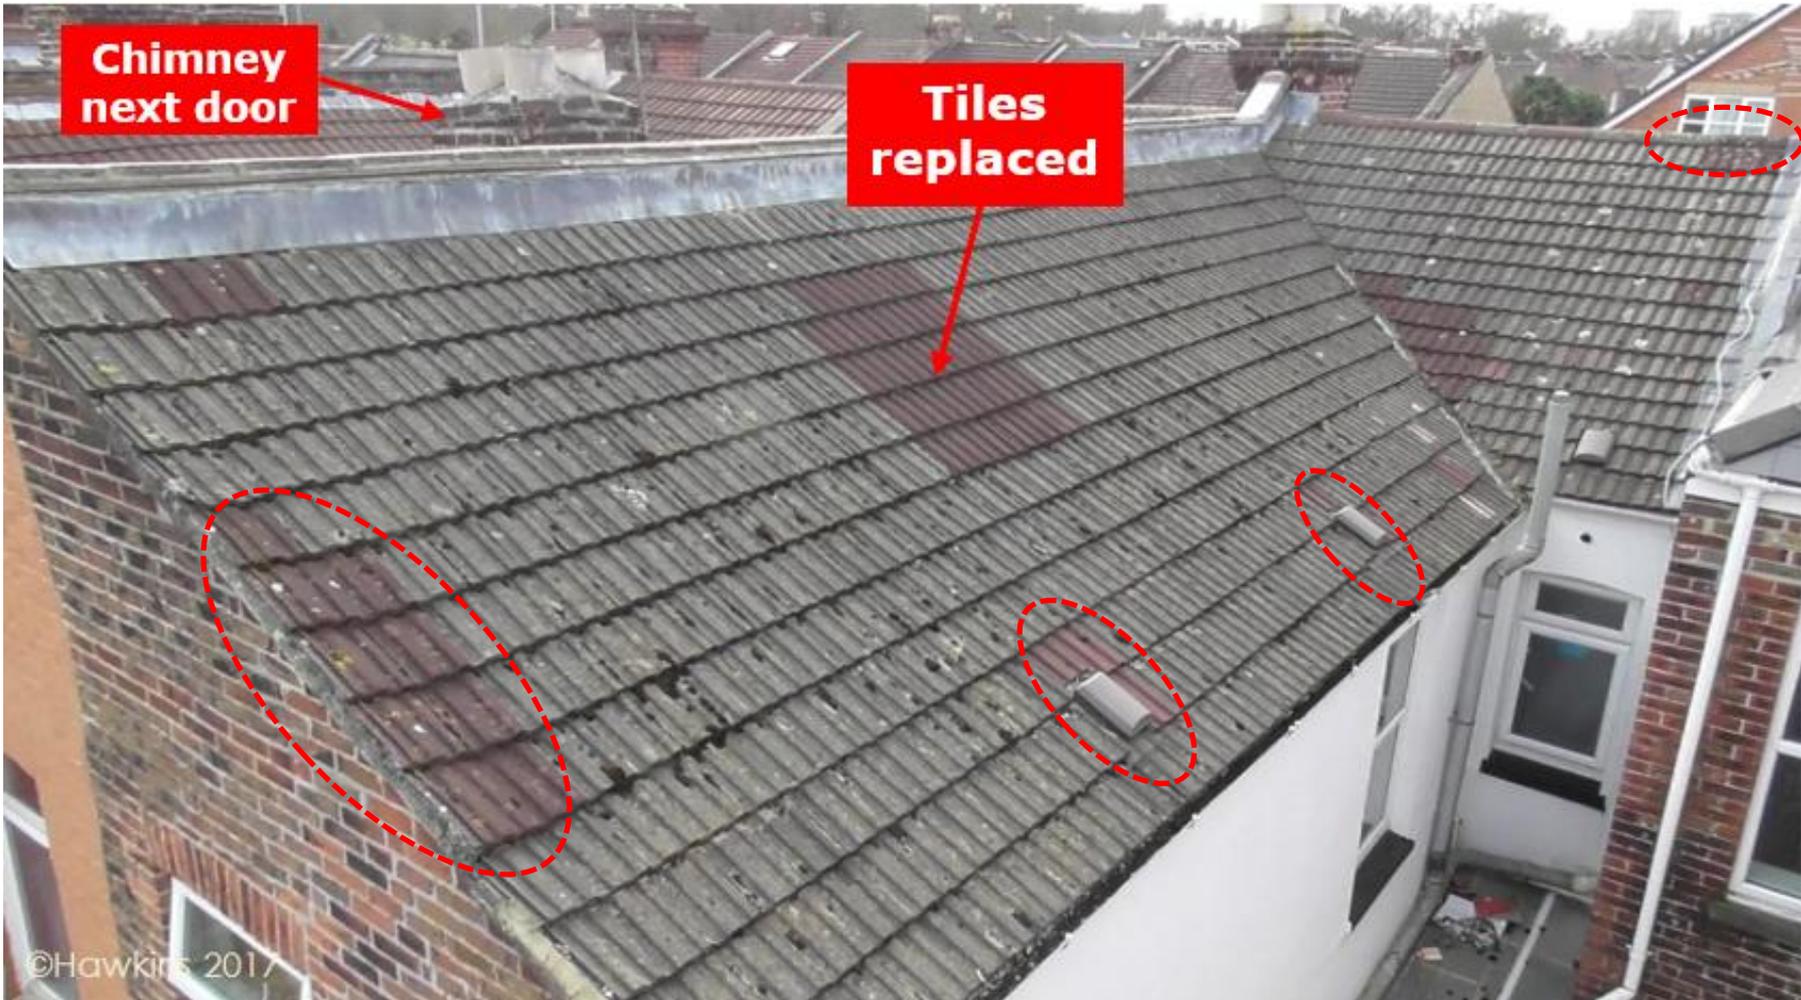
**Chimney
next door**

**Tiles
replaced**
