# Manchester Liability Society

## 6.5.1 : What is the Exposure

March 2016  
Daniel Storr  
Zurich Construction

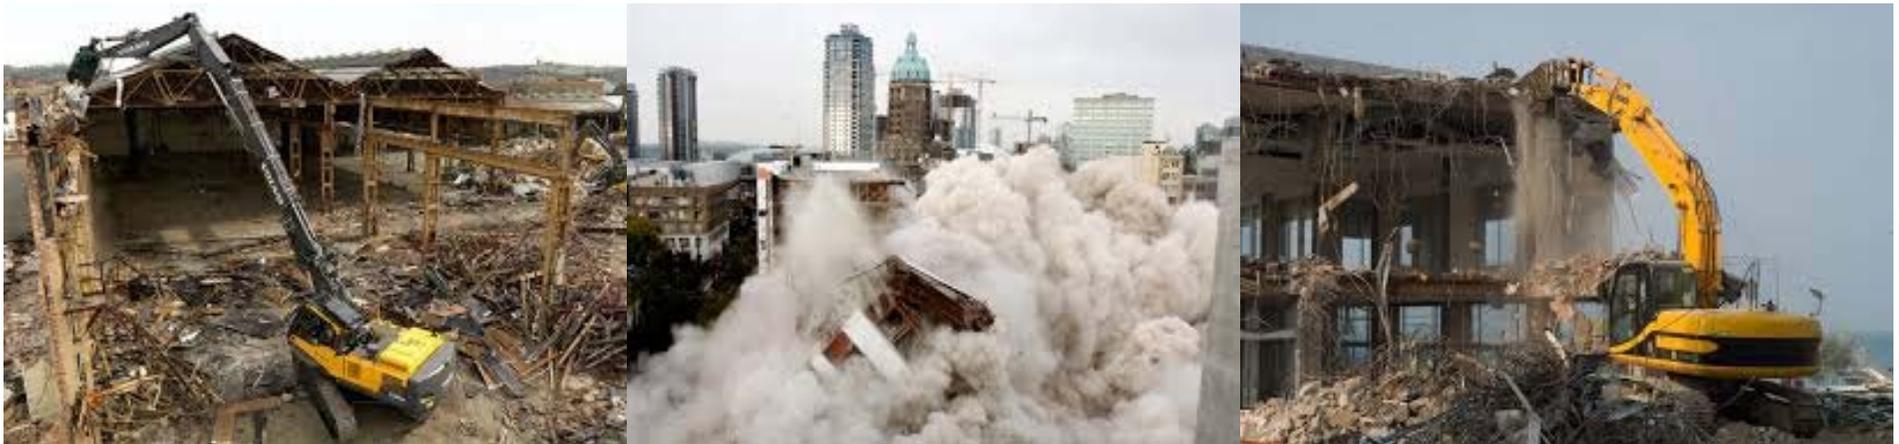
# Demolition

- Method - Hand, Machine, Explosives
- Vibration, Weakening or Removal of Support
- City Centre v remote
- Crushers = vibration

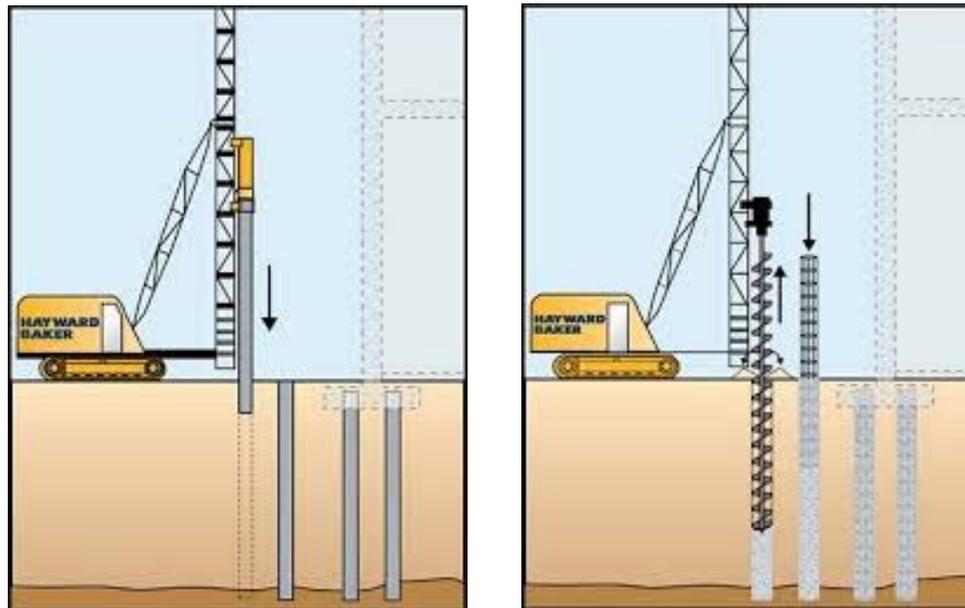
# Piling

- Method – Driven = Vibration
- Continuous Flight Auger = less vibration
- Screw piles = an option
- Number, depth & proximity
- Exclusion of “inevitable” damage is very relevant

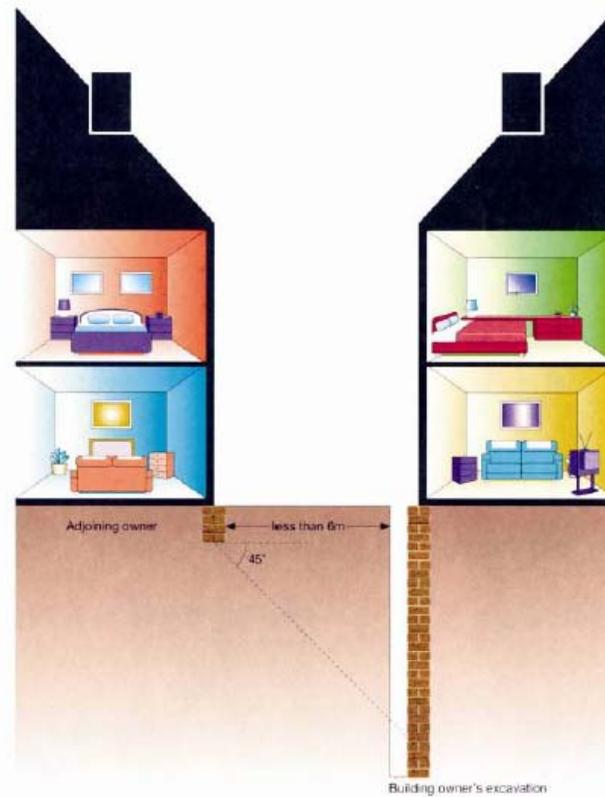
# Excavation

- Depth and proximity to other property
- Foundations of surrounding property
- New or additional basement levels
- Removal of support risk

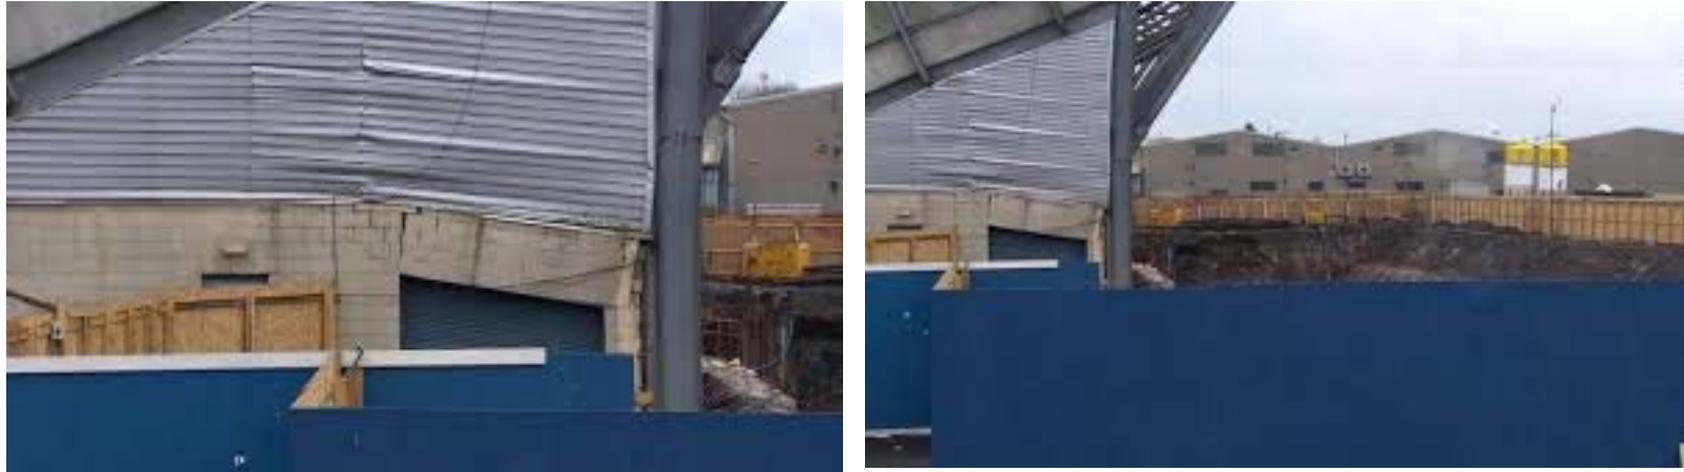
# Excavation - Windsor Park collapse

Cause yet to be established – possibly deep excavation?

### Windsor Park damage: Did excavation pit cause sinking of West Stand?

A giant hole close to the stricken West Stand is understood to be linked to the rebuild of Olympia Leisure Centre.

The vast pit is just feet away from the 5,000-capacity stand - also known as the Kop - which is now facing demolition, just 18 years after it was built.

It is not known if this excavation played any role in the subsidence crisis.

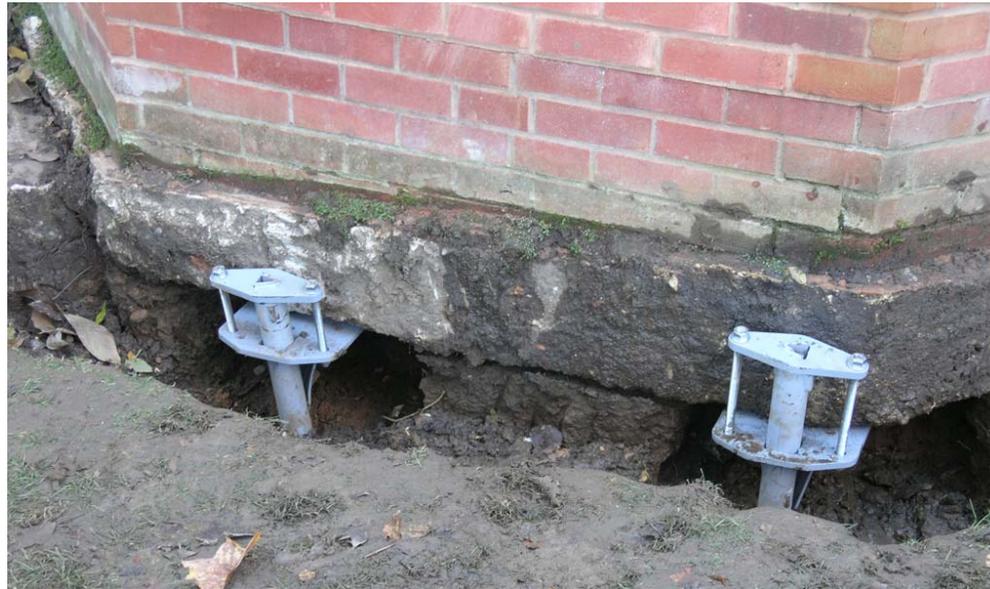
# Underpinning

- Can require excavation under existing building
- Length of underpinning required and maximum length any one bay – not to exceed 1.5M
- Risk of collapse and removal or weakening of support

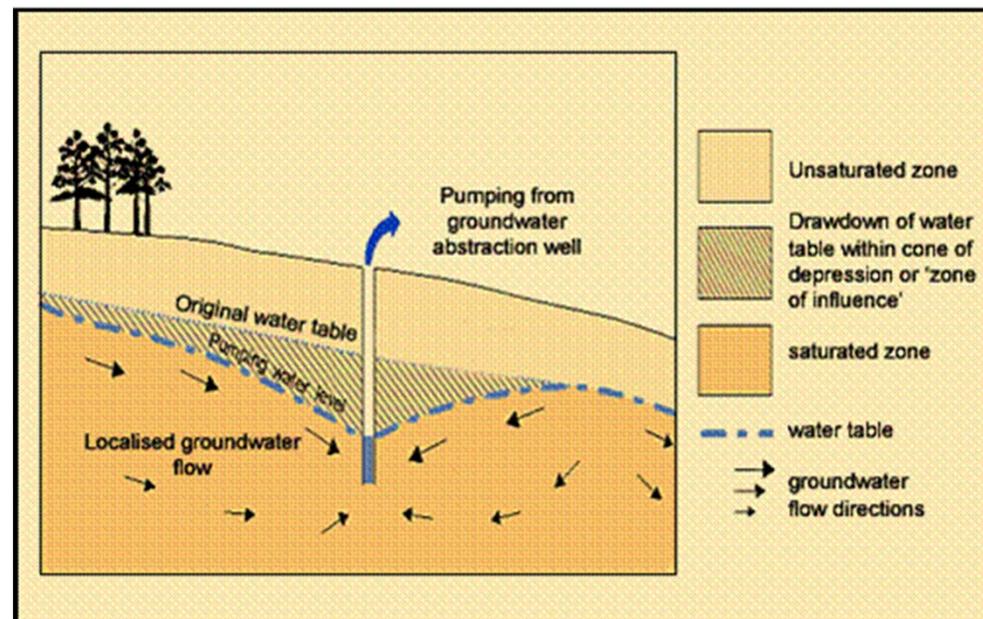
# Dewatering

- Act of removing groundwater or surface water
- Changes in groundwater changes the nature of ground support
- Lowering of ground water = ground settlement and structural movement (Subsidence)

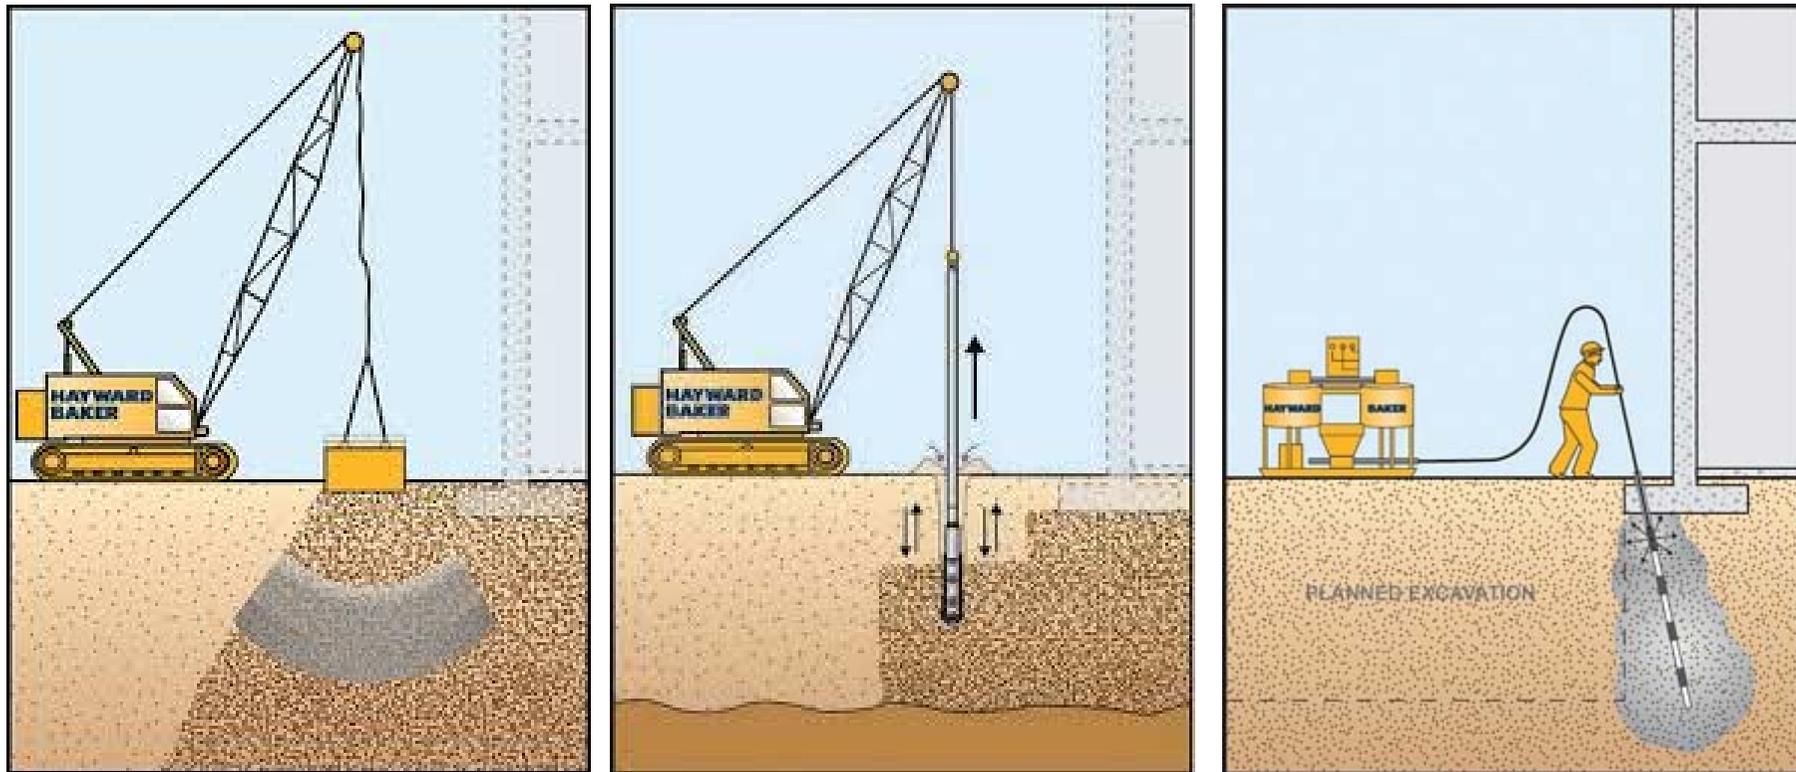
# Ground Compaction/Stabilisation

- Increases the density of soil
- Methods include impact and vibro compaction - vibration
- Grout injection - heave

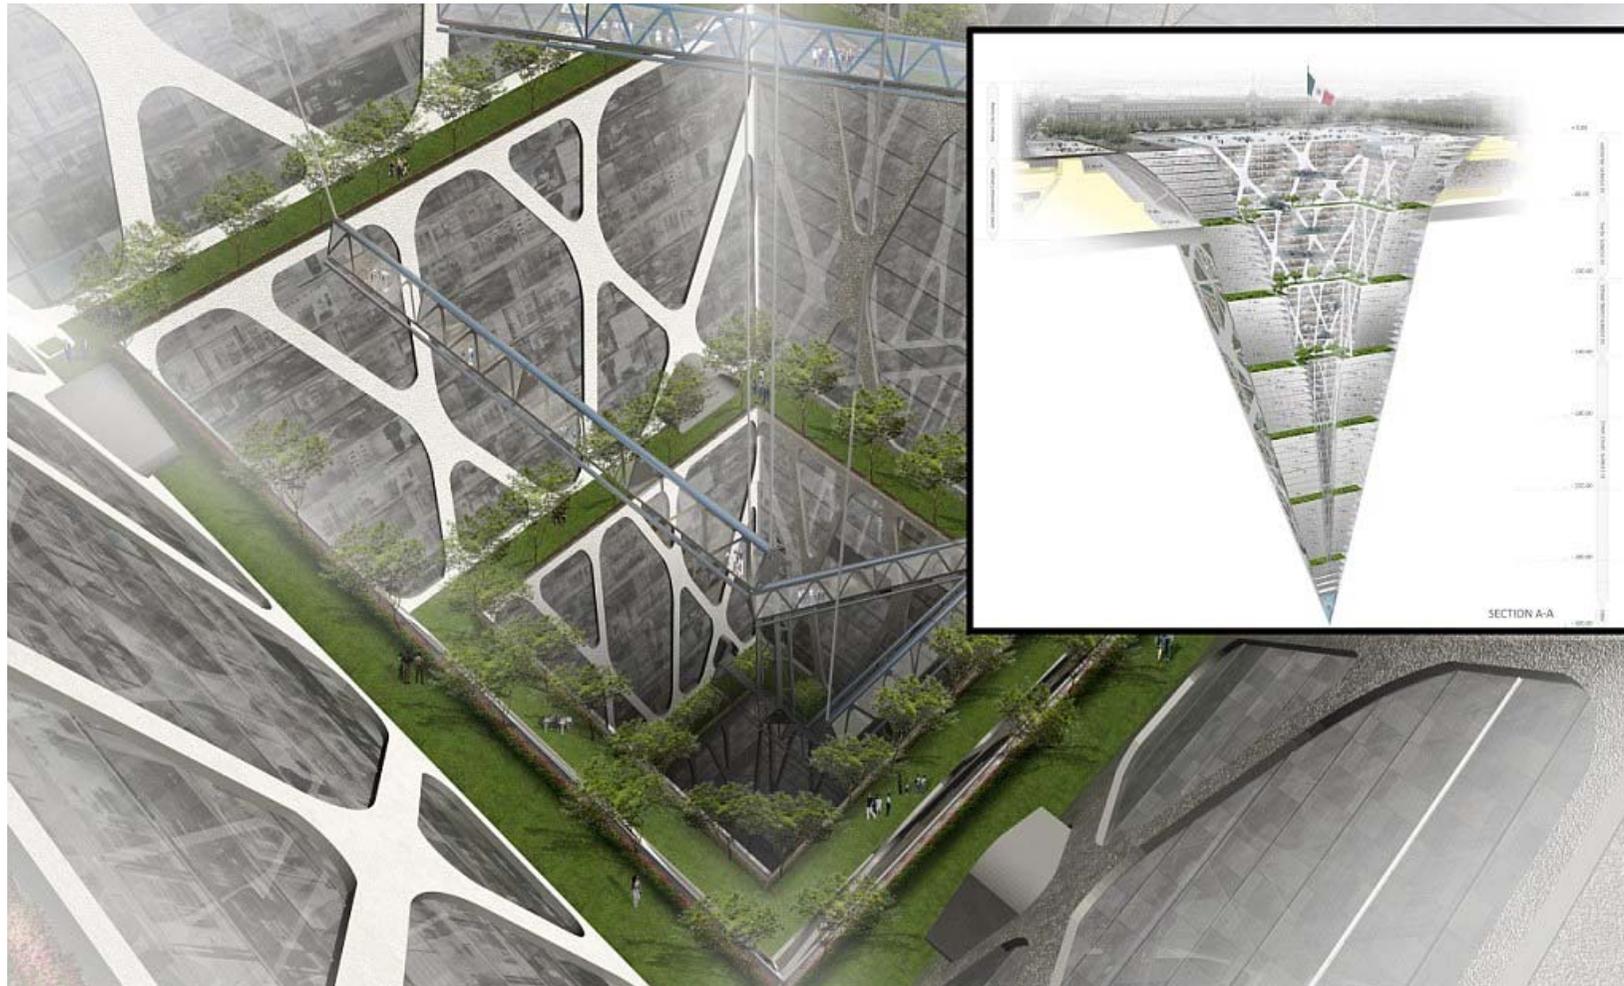
# Typical Contract...in the future?

Architects have designed a 65-storey “earth-scraper” which plunges 300M below ground and deals with Mexico’s planning restrictions on the height of buildings in Mexico City

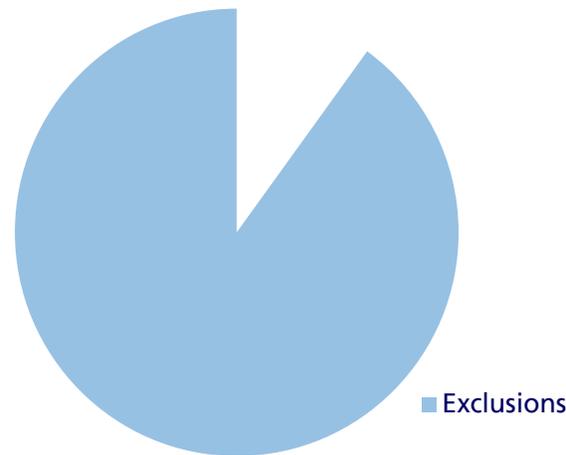
# What is the Exposure? – Clause Exclusions

1. Removal of support due to deep excavation below the depth of adjoining foundations – contractor’s negligence with Contractors PL to apply
2. Collapse caused by incorrect shoring design – professional negligence with Designers PI to apply.
3. Damage caused by driven piling within a small radius of the piling hammer - this can be “reasonably foreseen to be inevitable” and not within the scope of the clause.

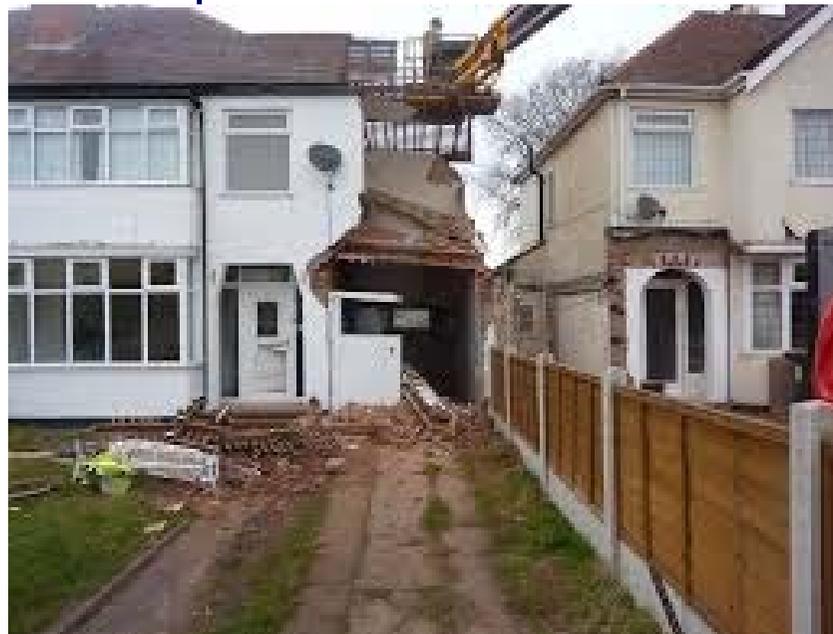
# What is the Exposure? – What may be included

Removal of support resulting from unforeseen ground conditions encountered during excavation – with the claim investigation confirming all technical standards and ground investigation protocols have been complied with

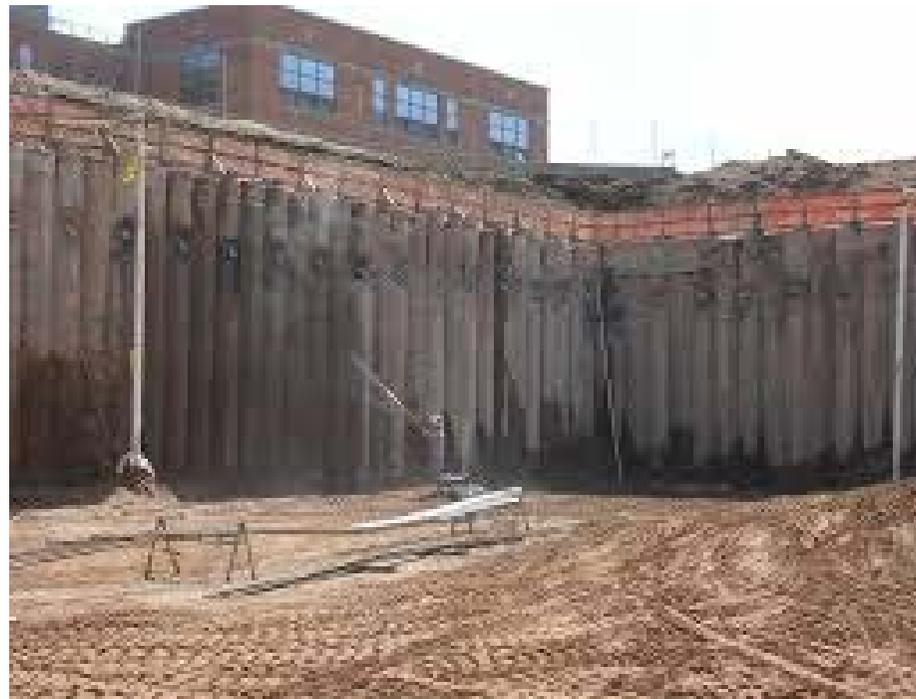
# What is the Exposure? – What may be included

Removal of support due to defective materials within steel piled walls that support a basement excavation – defects not attributable to negligent design or installation
