The Forensic Investigation of Domestic Property Fraud

CII Local Institutes Conference 2019

18 September 2019

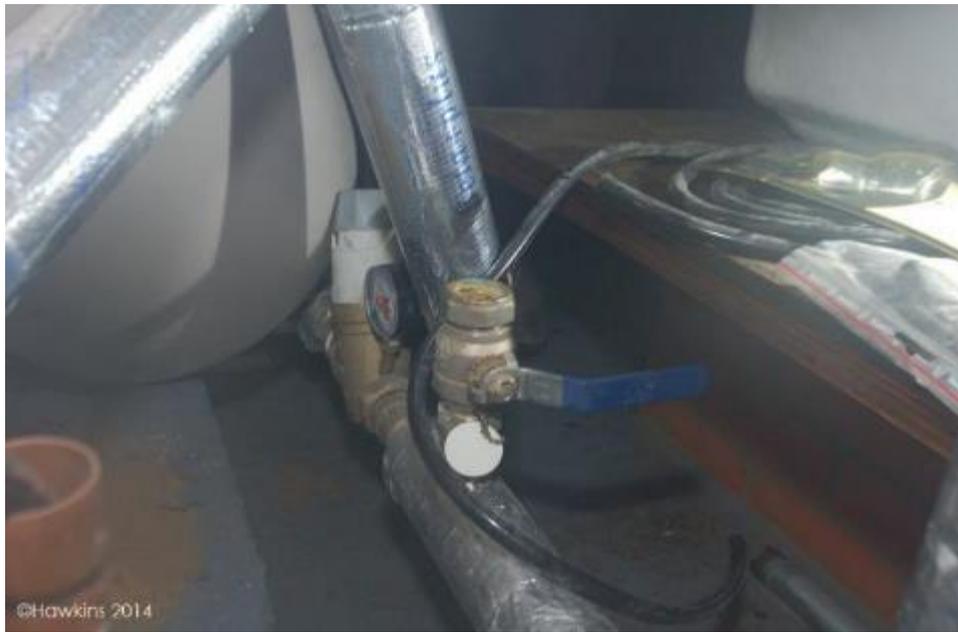
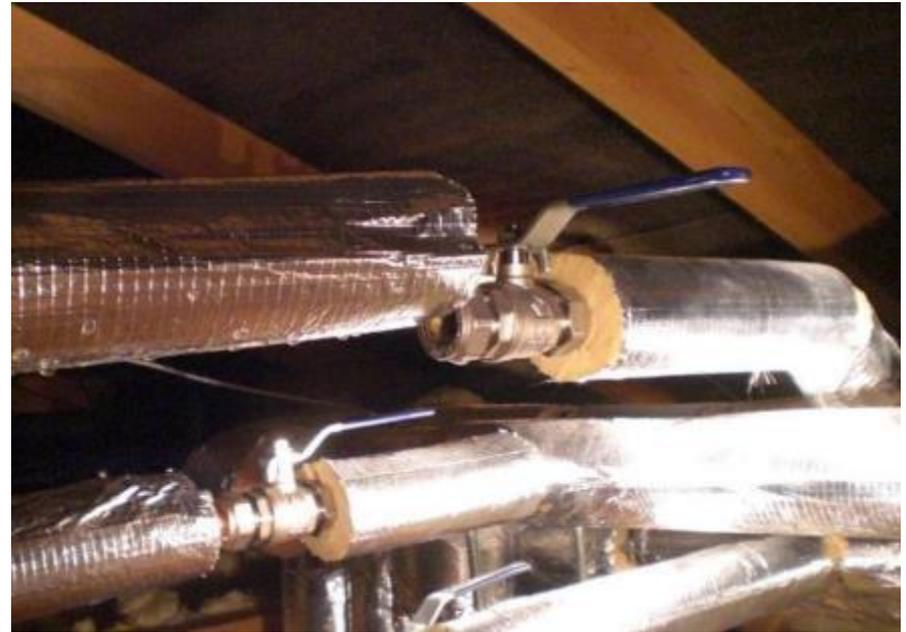
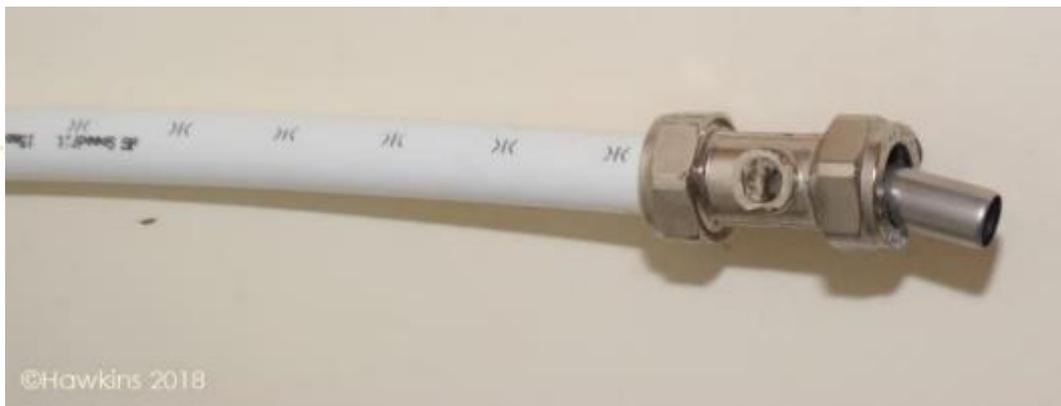
Separated joints

- Witness marks showing evidence of installation
- Joints that have been repaired will often exhibit multiple sets of marks
- The pipe end is just as important as the fitting
- Extremely large forces are required to pull apart a well made joint

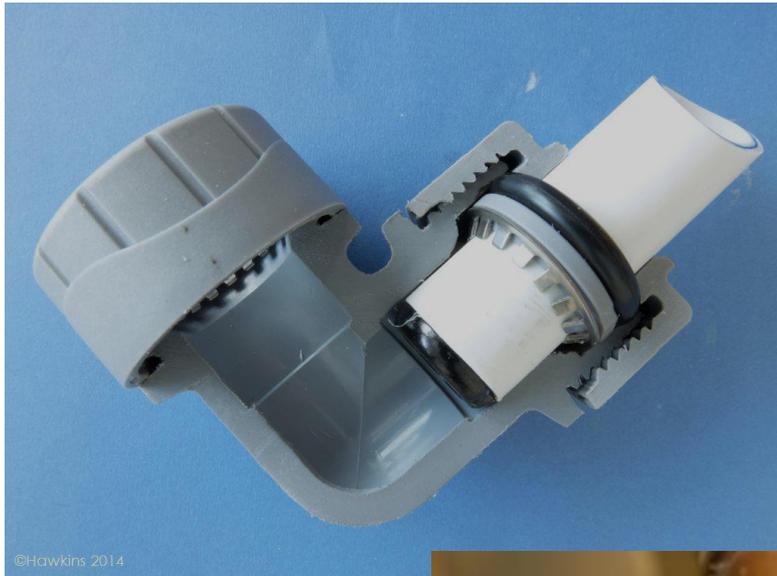
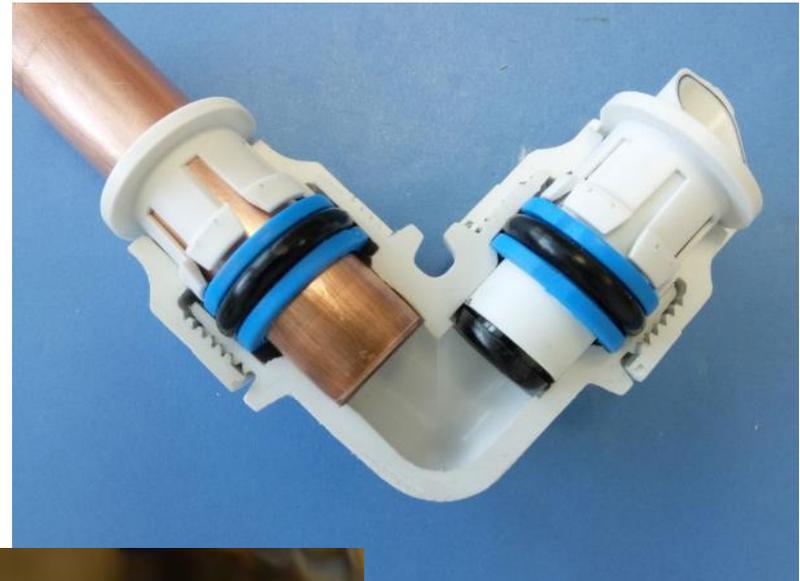
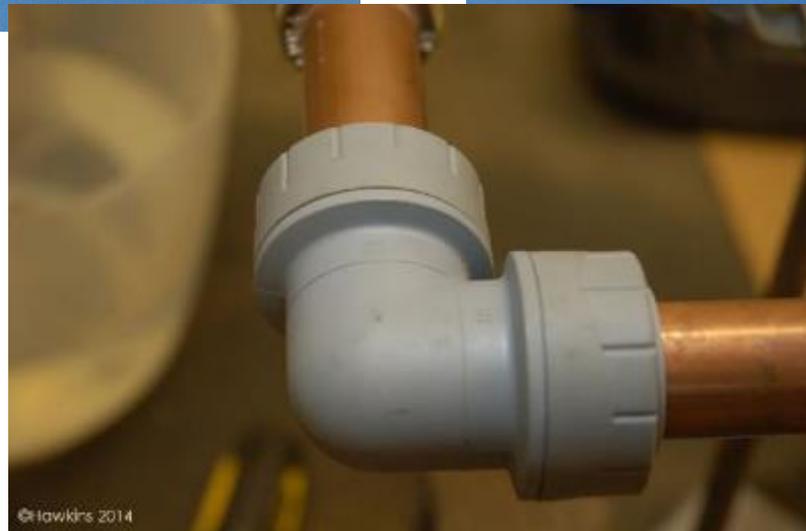
Separated joints

- The pipe is more useful than the fitting
- Plastic pipe is perfect for preserving witness marks
- Replicate damage in repeatable tests
- If the pipe is reused the original separation marks will still be present
- If there are no marks present then the pipe was never inside the joint (this could be poor workmanship as well)

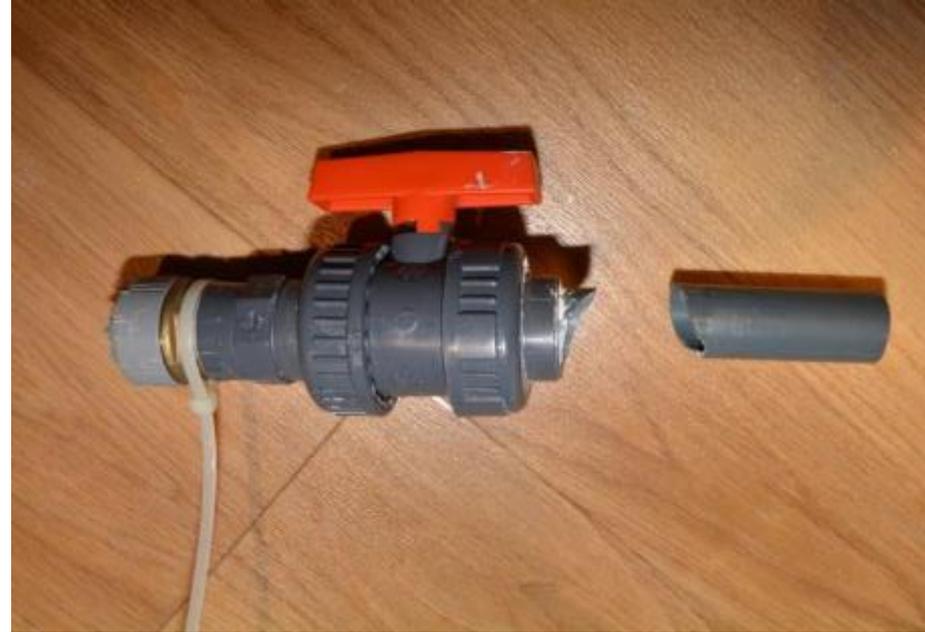
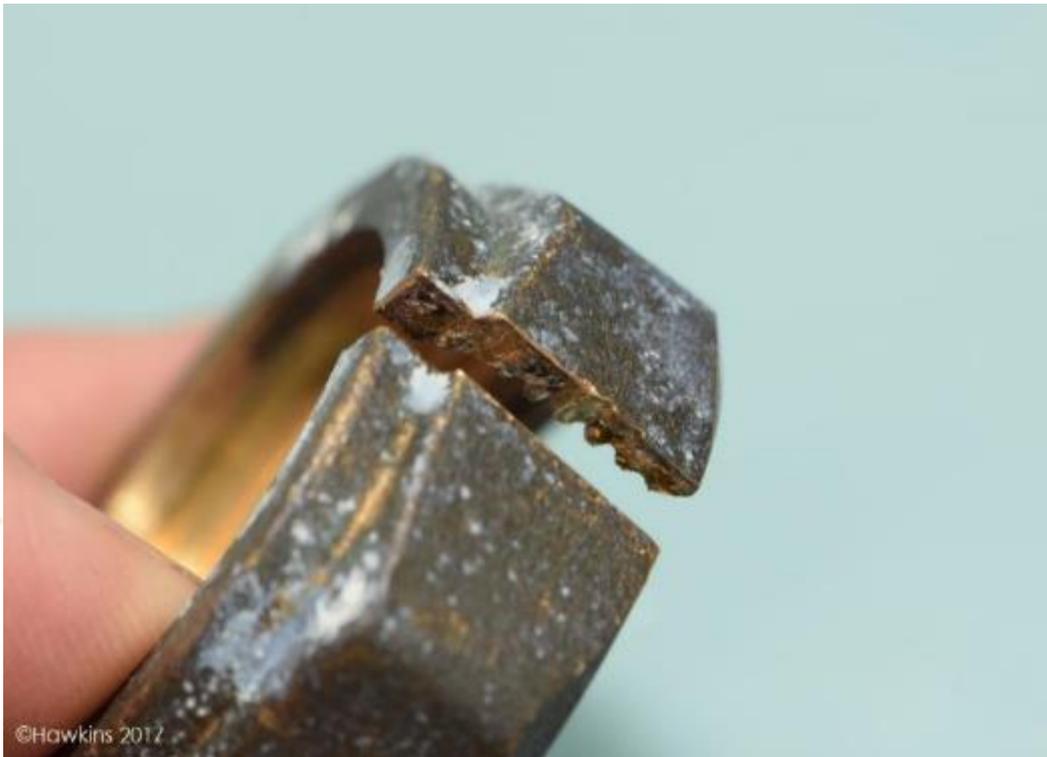
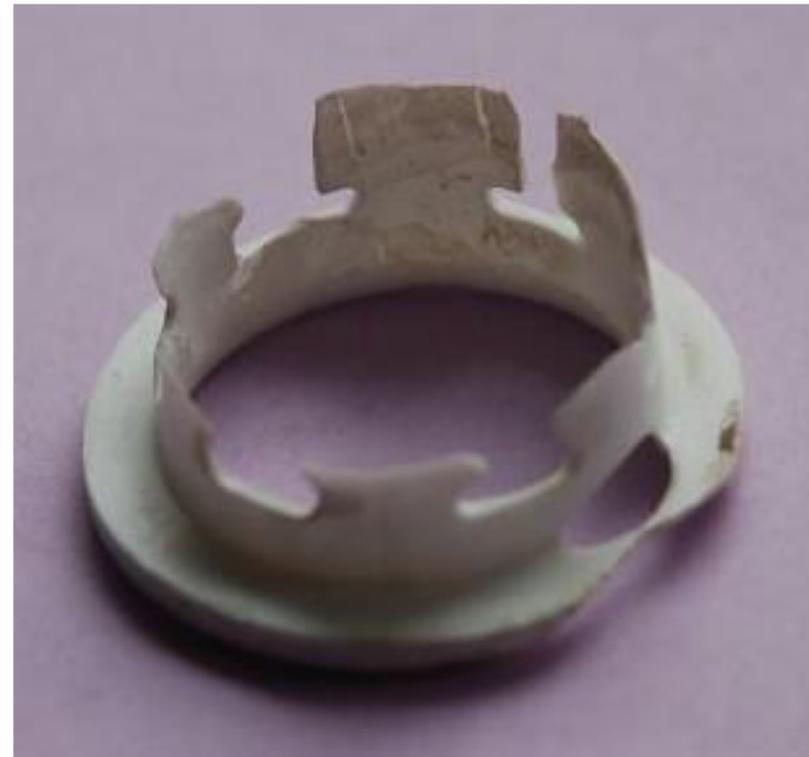
Material failures

- When a material fractures, patterns in the surface are created.
- If the surfaces are preserved these clues can help establish what has occurred
- The fracture patterns tell us where a crack started and how quickly it grew.
- The patterns can also indicate when unusual forces have been applied and in what direction.

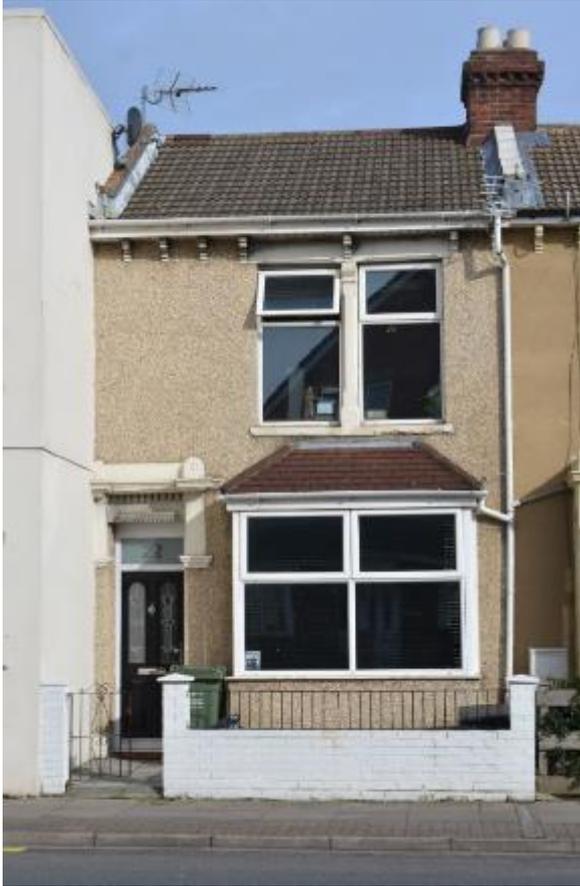
The scene of (part of) the crime?

- Purchase: 4 November 2013
- EoW: 29 November 2013
- Storm damage: 24 December 2013
- Both claims investigated by Macey
- Repairs scheduled by Macey
- Cash settled on basis of scheduled costs
- “Buildings” payments of approx. £50k

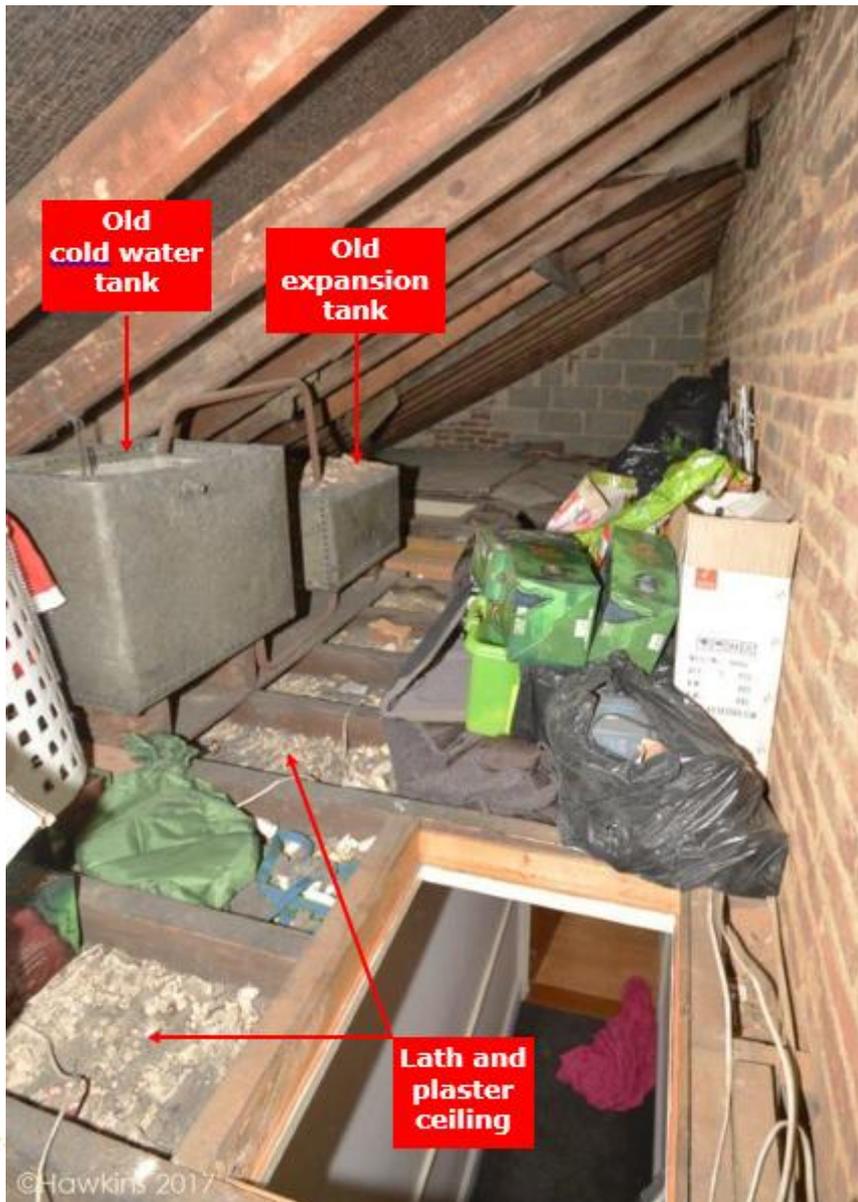
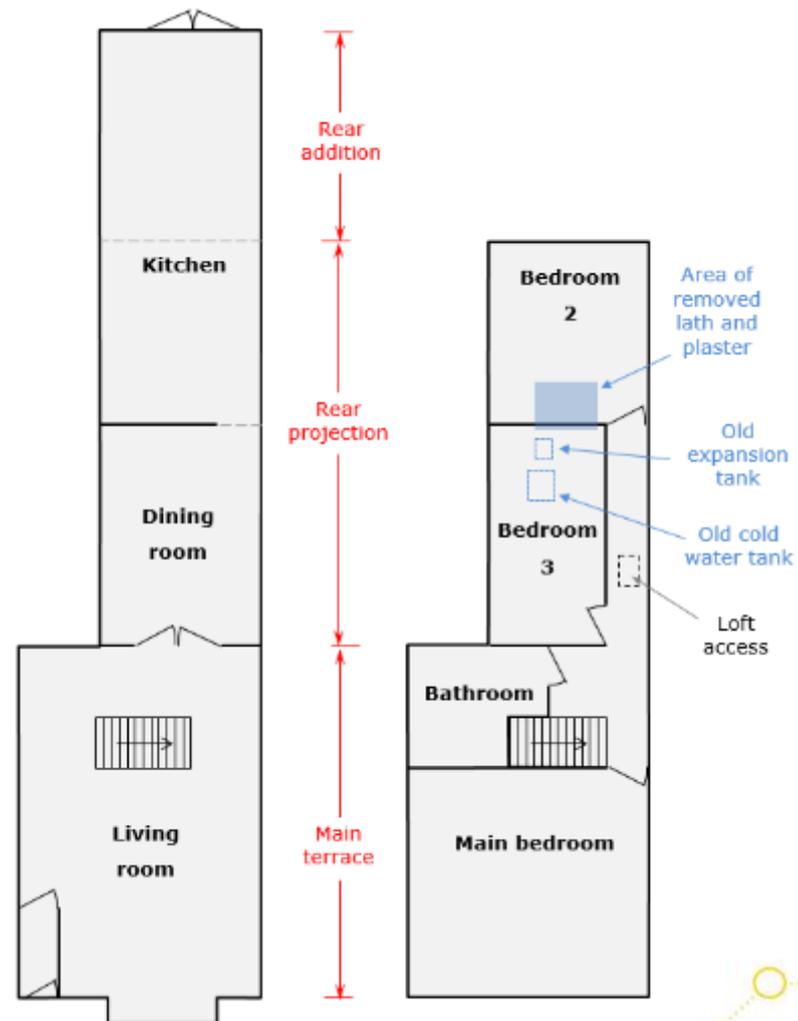
Main terrace loft, looking towards the rear
